**SAM G55 Series Family  
Silicon Errata and Data Sheet Clarification**

The SAM G55 Series family of devices that you have received conform functionally to the current Device Data Sheet (Atmel-11289F-ATARM-SAM-G55G-SAM-G55J-Datasheet\_27-May-16), except for the anomalies described in this document.

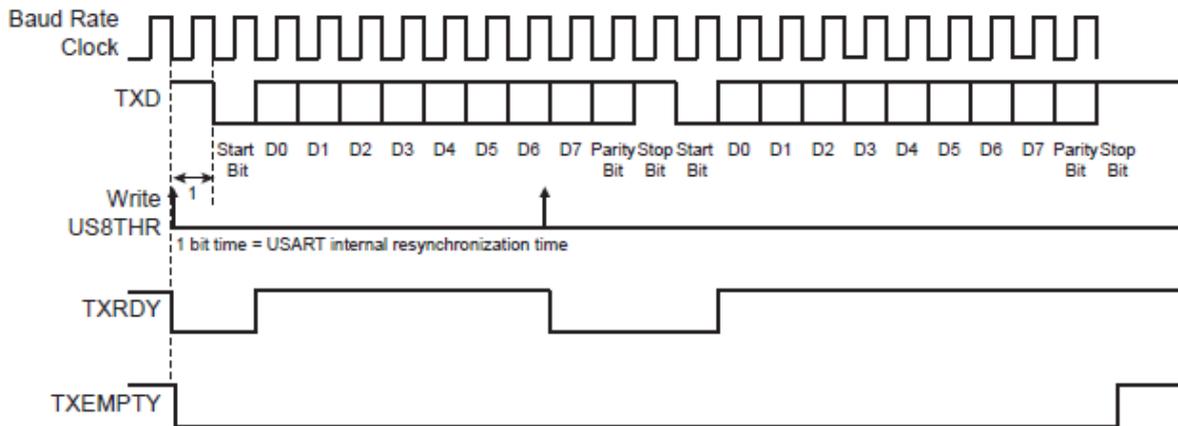
## 8. Module: USART - Transmitter Operations

Figure 30-6 is incorrect. The corrected figure is as shown below:
