## ABSTRACT

This document describes the known exceptions to the functional specifications (advisories).

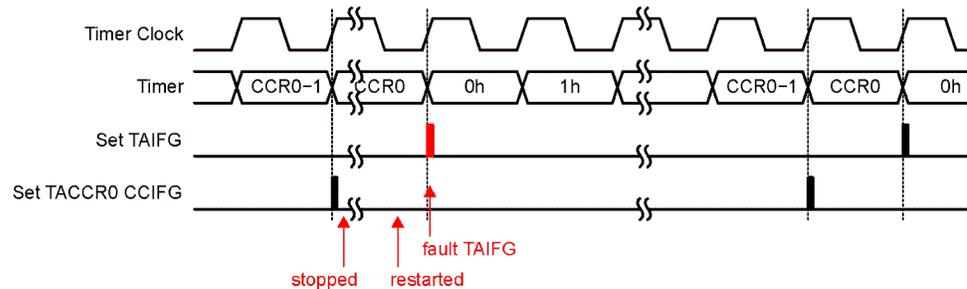
## TA21 *TA Module*

**Function** TAIFG Flag is erroneously set after Timer A restarts in Up Mode

**Description** In Up Mode, the TAIFG flag should only be set when the timer counts from TACCR0 to zero. However, if the Timer A is stopped at TAR = TACCR0, then cleared (TAR=0) by setting the TACLK bit, and finally restarted in Up Mode, the next rising edge of the TACLK will erroneously set the TAIFG flag.

**Workaround** None.

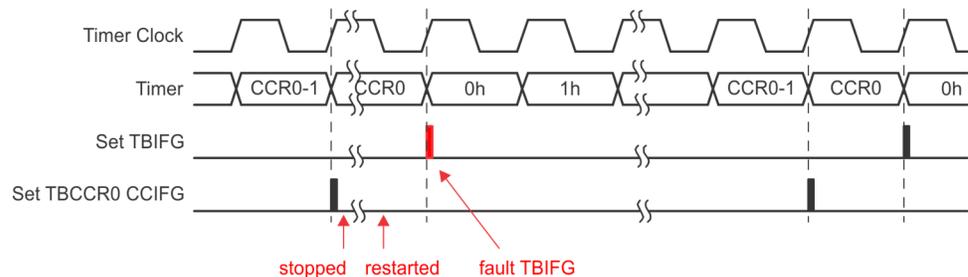
**TB24** *TB Module*

**Function** TBIFG Flag is erroneously set after Timer B restarts in Up Mode

**Description** In Up Mode, the TBIFG flag should only be set when the timer resets from TBCCR0 to zero. However, if the Timer B is stopped at TBR = TBCCR0, then cleared (TBR=0) by setting the TBCLR bit, and finally restarted in Up Mode, the next rising edge of the TBCLK will erroneously set the TBIFG flag.

**Workaround** None.
