## MSP430TCH5E Device Erratasheet

### 1 Functional Errata Revision History

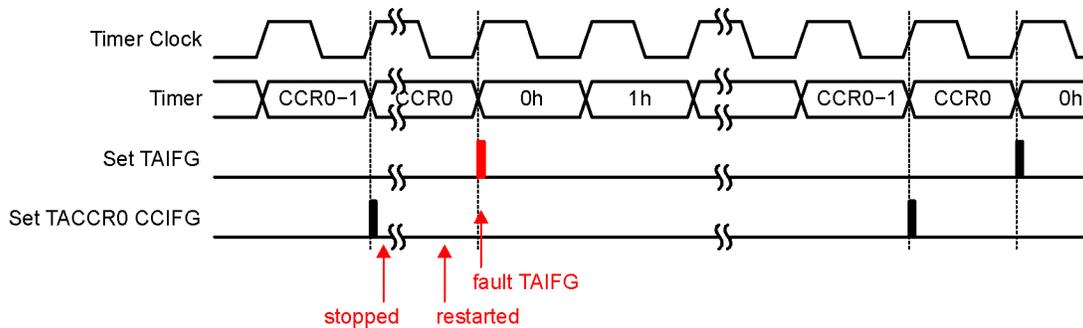
**TA21** *TIMER\_A Module*

**Function** TAIFG Flag is erroneously set after Timer A restarts in Up Mode

**Description** In Up Mode, the TAIFG flag should only be set when the timer counts from TACCR0 to zero. However, if the Timer A is stopped at TAR = TACCR0, then cleared (TAR=0) by setting the TACLR bit, and finally restarted in Up Mode, the next rising edge of the TACLK will erroneously set the TAIFG flag.

**Workaround** None.
